St. James' Church, Wick 19549

Condition Report

November 2019

South East Window survey

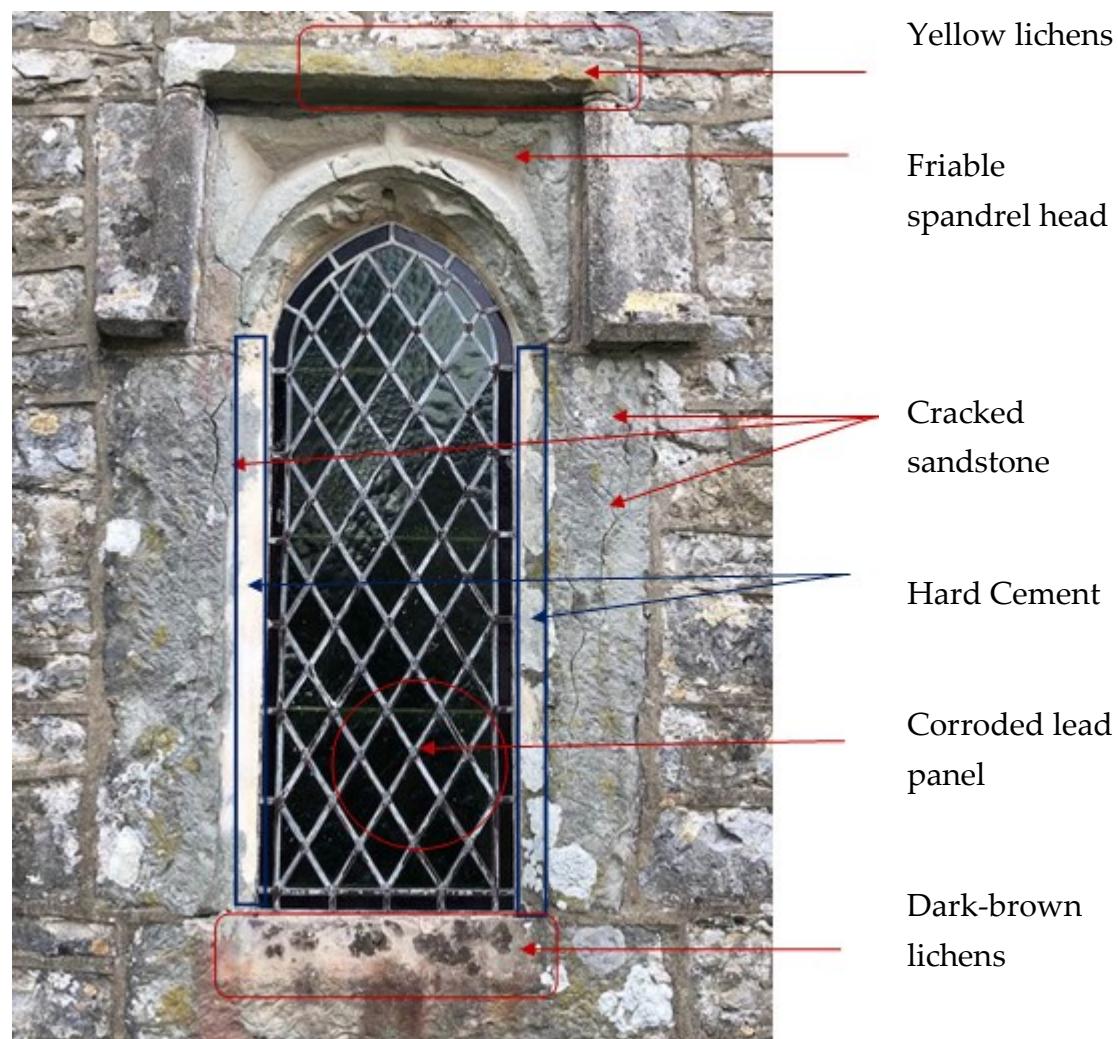
Diagram 1 Surface and structural damages of the chancel window

damaged areas (Diagram 1). The glass panel is severely bulging toward outside but remains stable (Figure 7). The condition of the masonry frame is unstable and shows signs of delamination, resulting in very friable stone surface in some areas (Figure 5 & 6). Once delamination begins, it is difficult to halt the decay process but is possible to slow down the rate. This is a result of moisture penetration leading to freeze thaw action and salt crystallisation, causing the stone to cleave along its weak point. The cement mortars and pointing used to replace original deteriorating lime mortar are causing additional structural damage to the stonework as the trapped moisture escapes through the face of the stones rather than the pointing. There is also lichen colonisation on the surface of the stone which is not causing any appreciable damage to structure of the stone but is at present an aesthetic consideration.

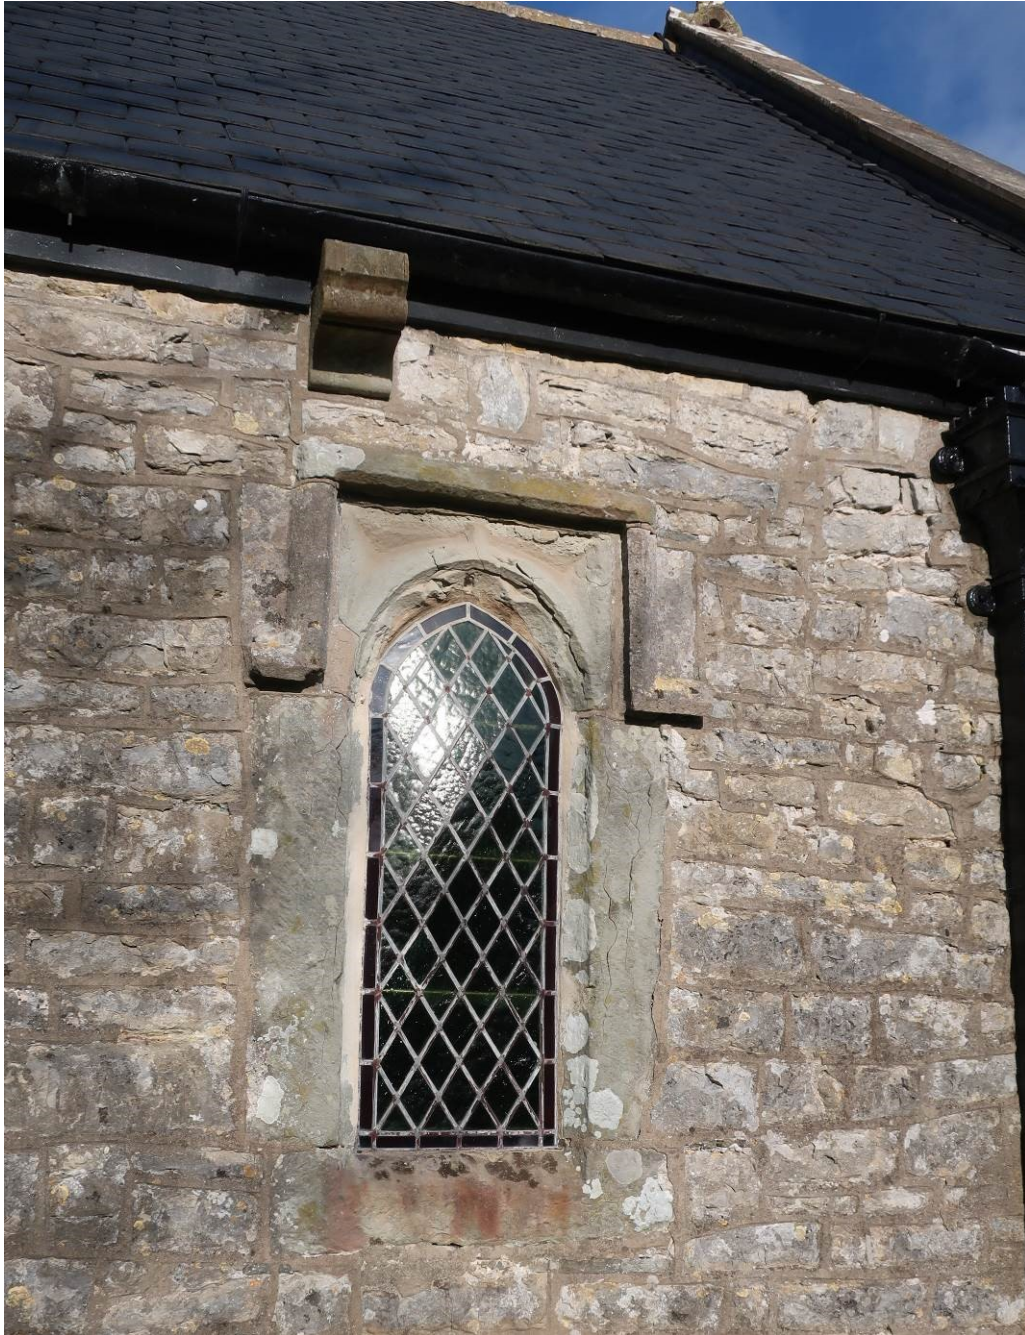
Figure 1 Picture taken from ground level of the current state of the chancel window and on the top and right-hand side there is evidence of the French draining system

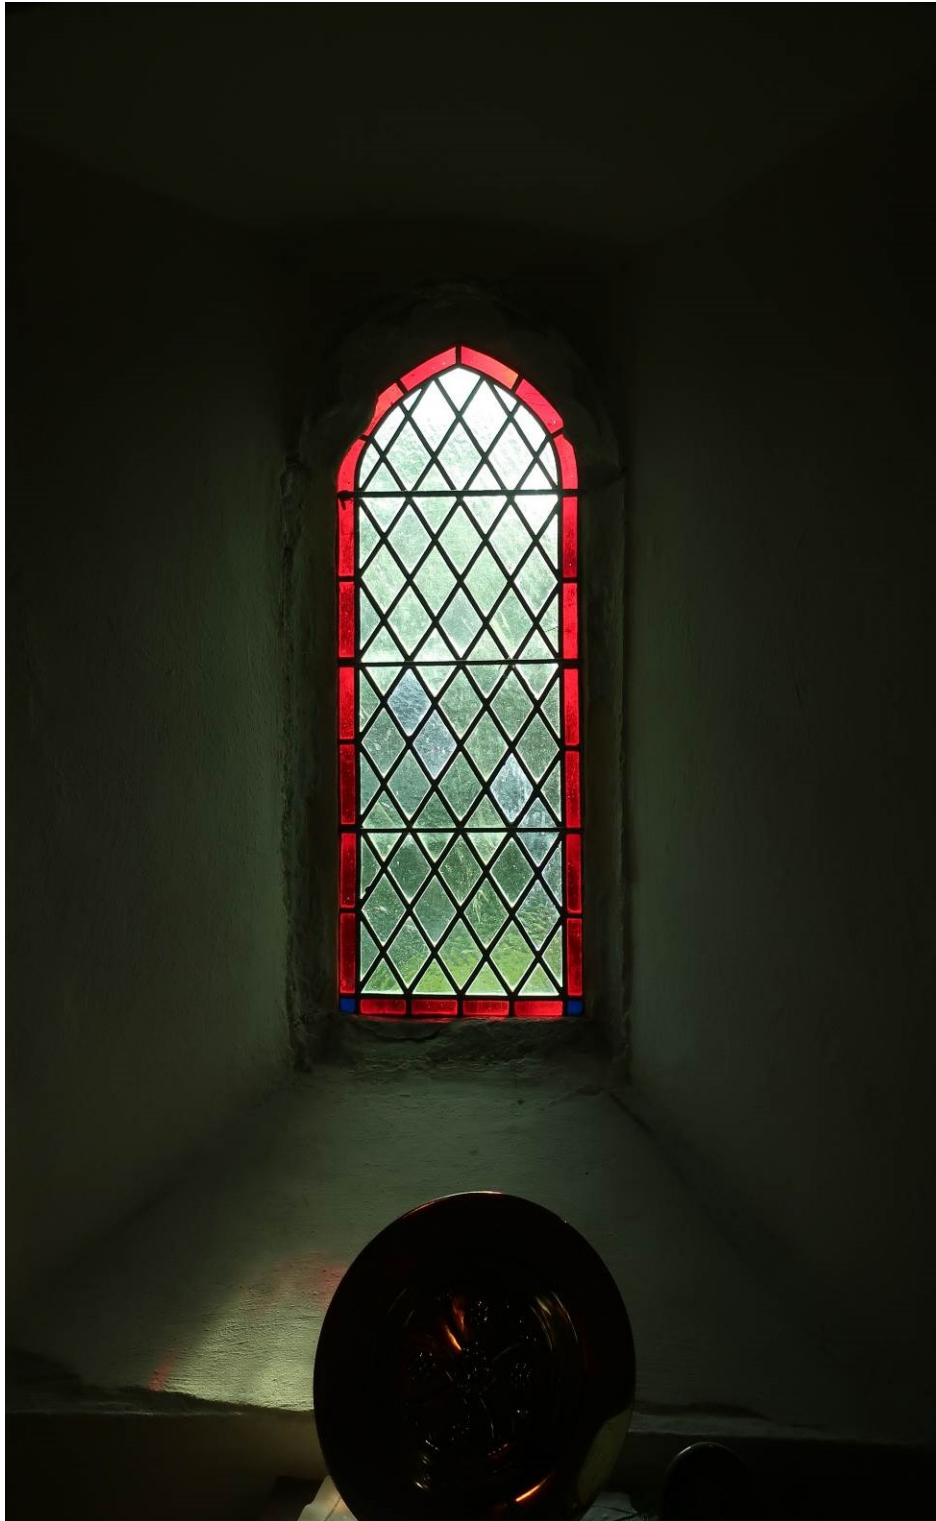
Previous repairs to the original lime pointing with new cement strap pointing are affecting the build up of moisture in the masonry. There appears to be a relatively recently installed French drainage system close to the window which appears to be in good order with clean gutters, diverting the rainwater off the window (Figure 1). The inside wall of the chancel window appears in good condition with no moisture signs or paint blisters (Figure 2).

Figure 2 Photo taken from inside the chancel showing that there is no visible damage to the indoor wall of the window

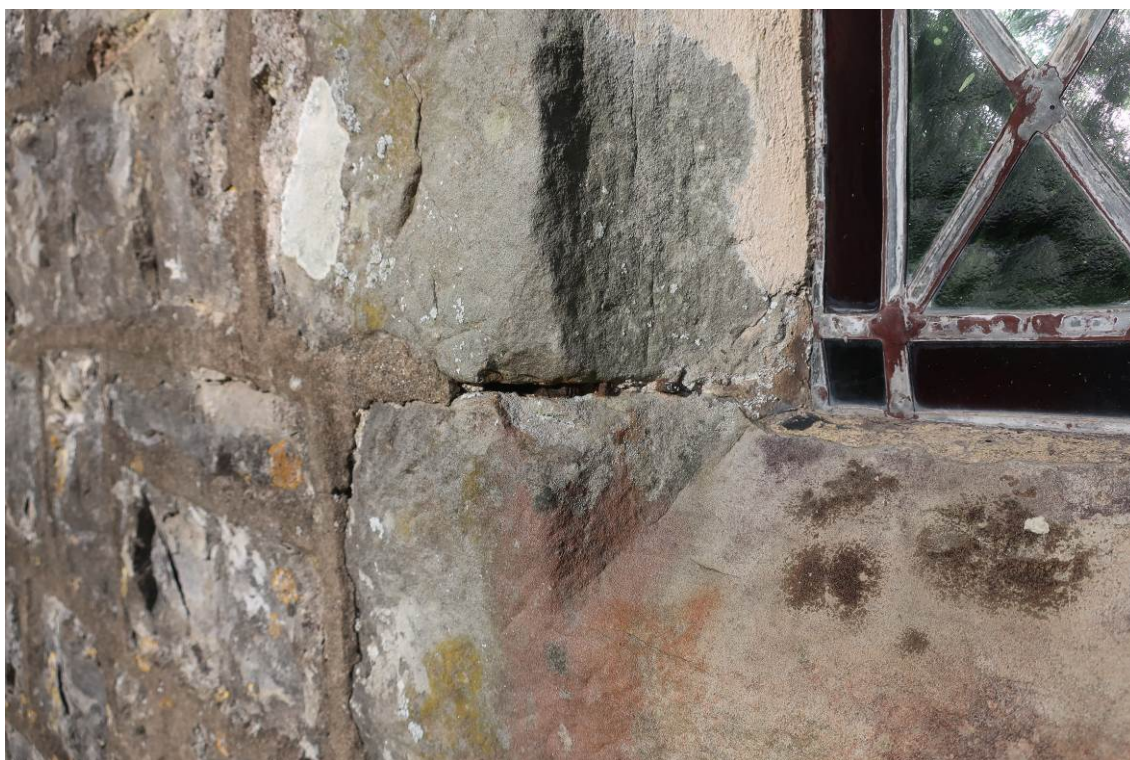
On the surface of the hood moulding and on the stone cill of the window of the window there is some yellow and dark-brown lichen colonisation. The sandstone surrounding the window and the double spandrel head stone above the arch show signs of delamination and the surface is quite friable (Figure 3 & 4). Due to the severe delamination in the area, the shape of the arch is not sharp with large areas of stone missing from the top the arch.

Figure 3 Close up of the left bottom corner with evidence of lichen colonisation on the sill stone of the window. An open joint is also visible in this picture and part of the white hard cement between the stone frame and the lead panel

The window has been repaired with inappropriate hard cement. An attempt should be made to remove the peripheral joints and those surrounding the spandrel head. These should be replaced with a soft lime-based mortar. The stonework surrounding the window has been repaired with hard cement. Consideration should be given to replacing this if it does not prove to be too disruptive or does not compromise the window fixings. If successful these should be replaced with lime-based mortar repairs.

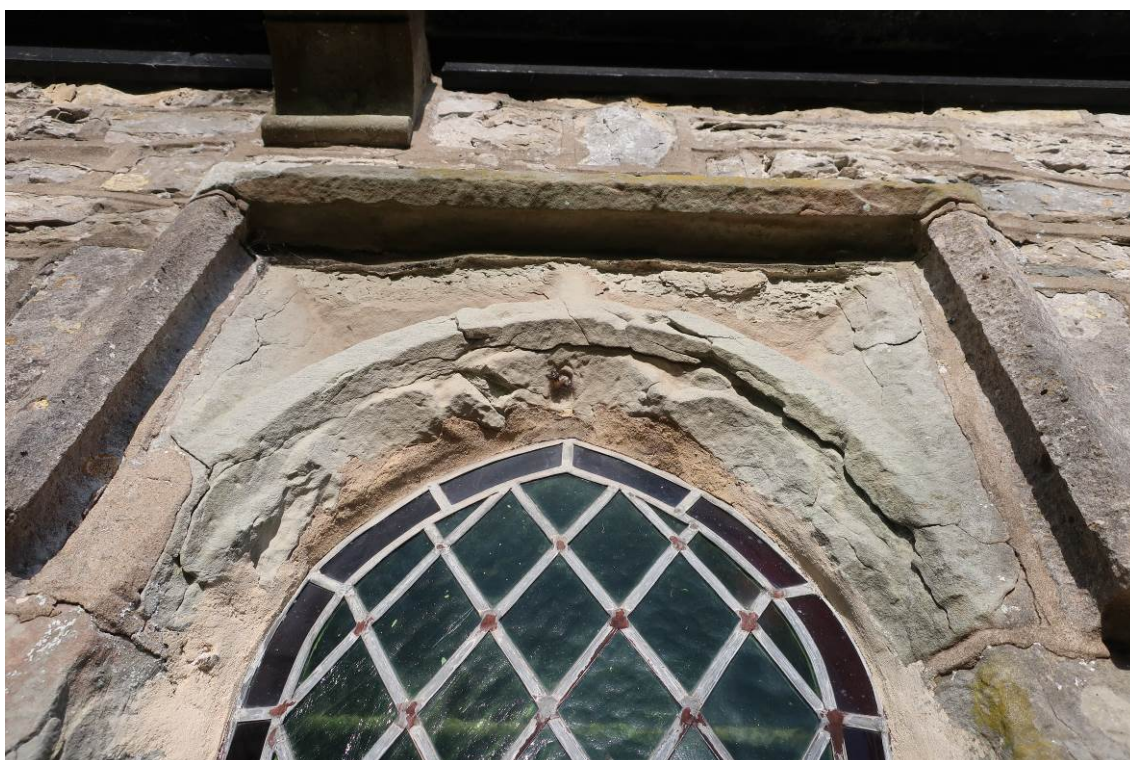
Figure 4 Close up on the arch and hood moulding structural damages caused by the delaminated stonework and incorrect hard cement pointing

All areas of delaminating stone should be flushed out with industrial methylated spirits (IMS) and water prior to grouting with a lime-based grout such as PLMA, (a proprietary lime-based grout). The grouted fissures should then be capped with soft lime-based colour-matched mortar. The decayed stone of the spandrel head should be treated in the same way.

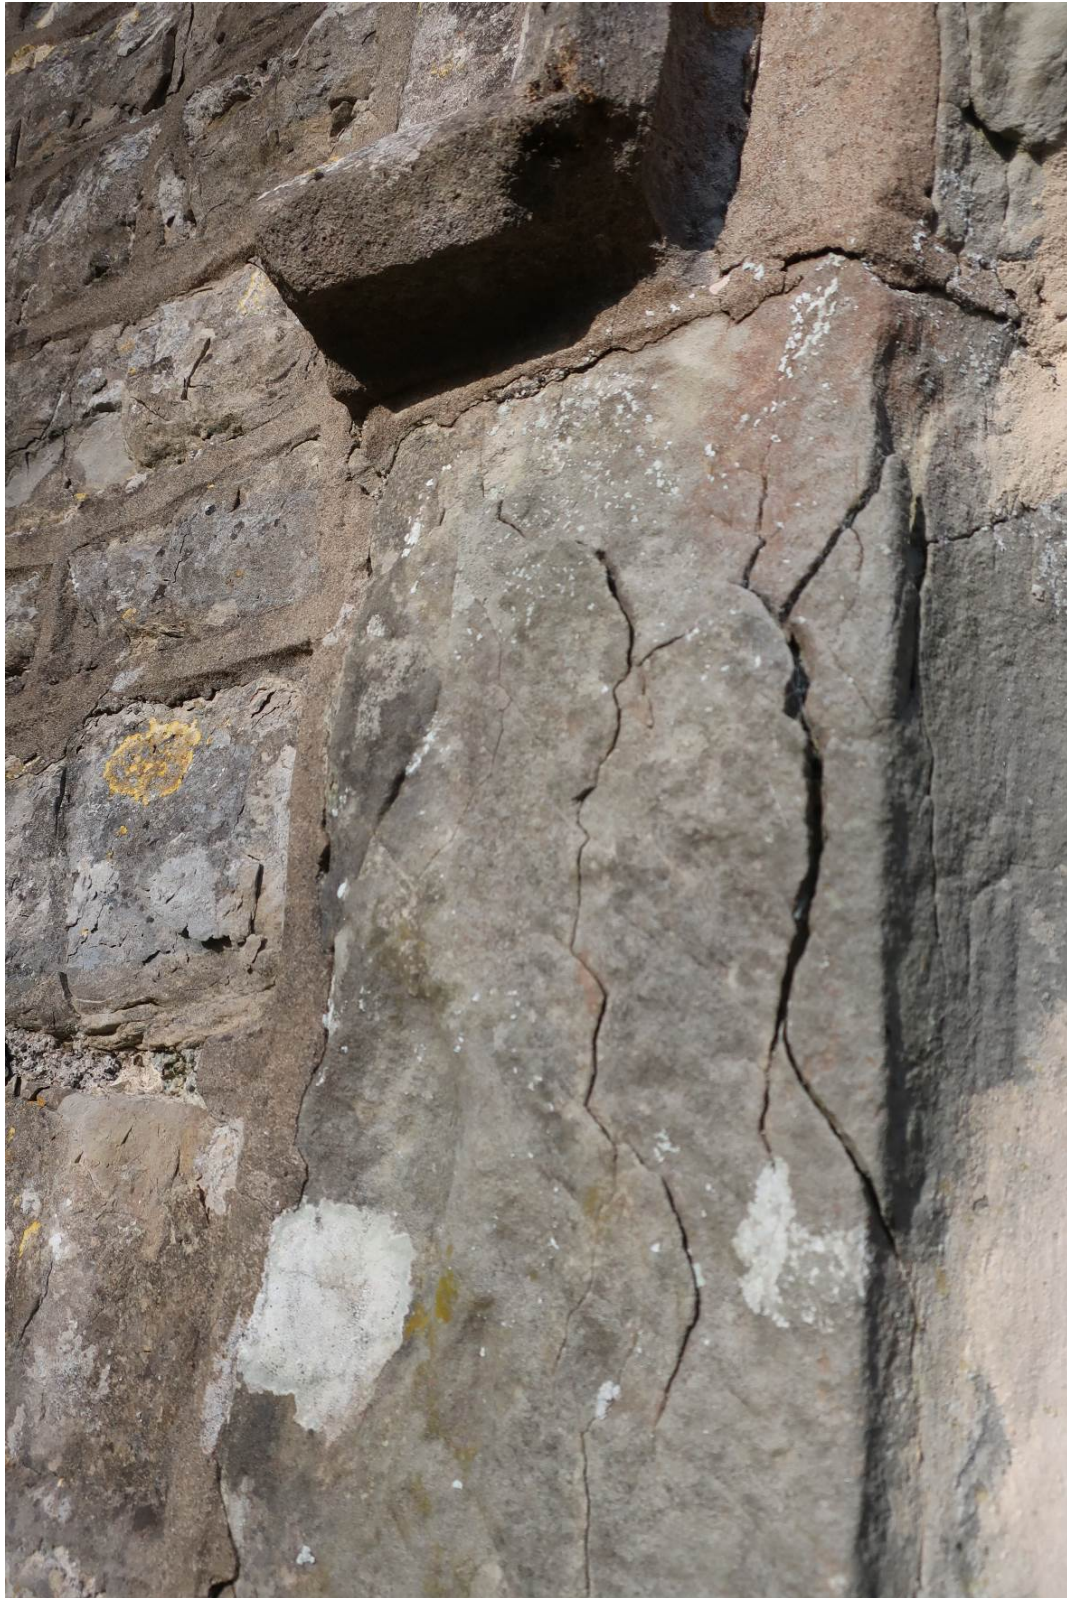
Figure 5 Delamination of the left-hand side the sandstone and lichen colonisation on the surface

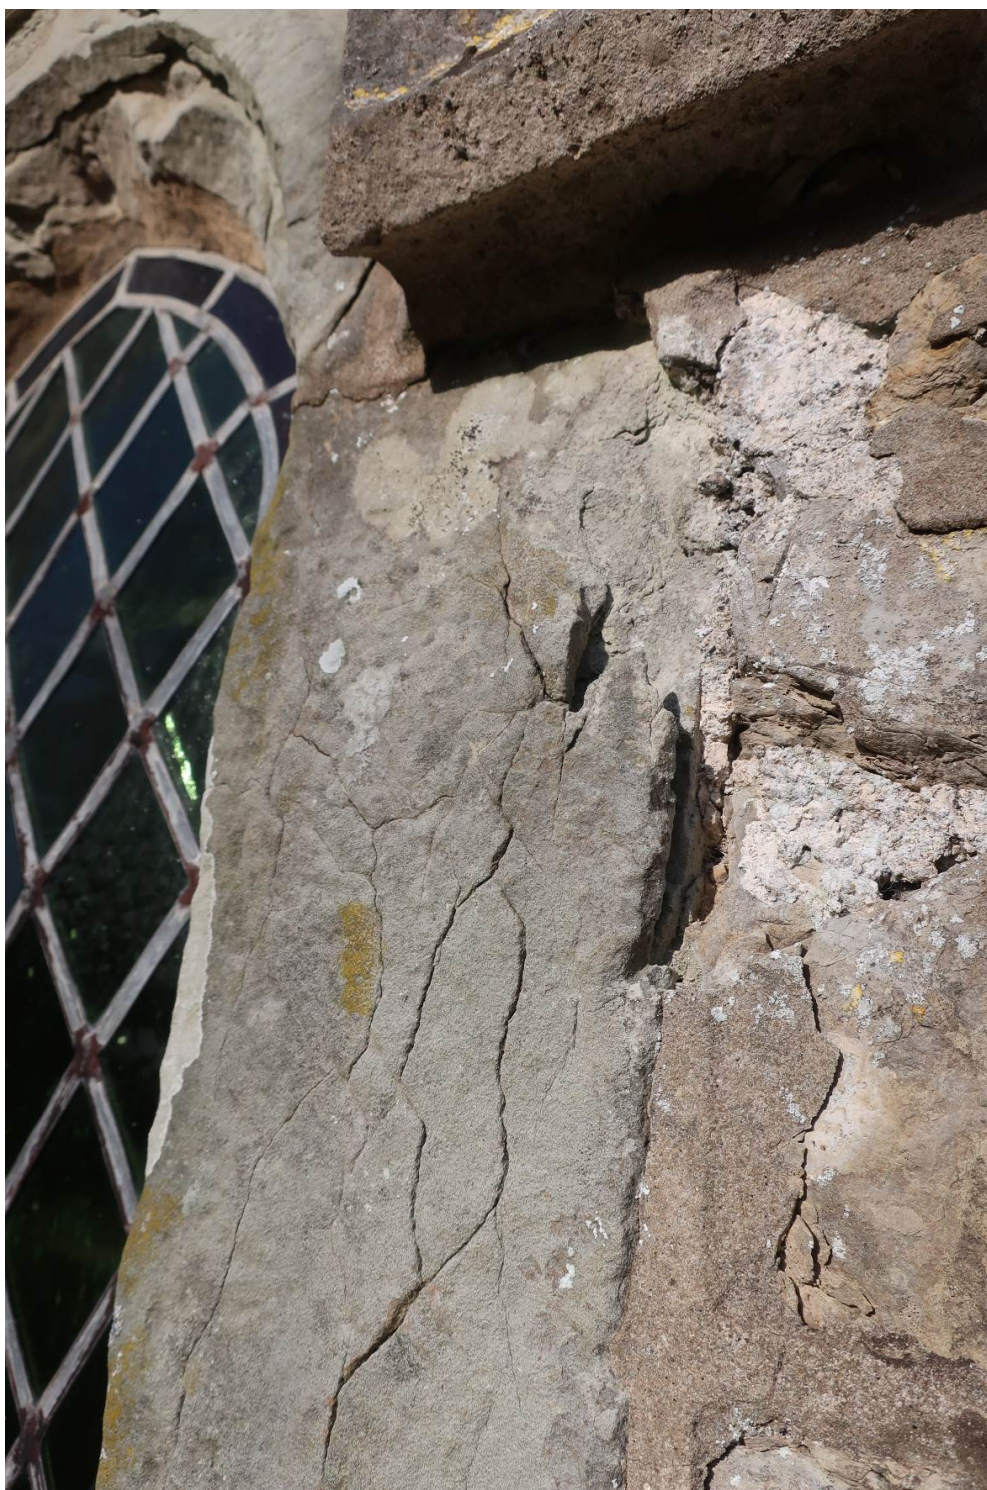
Figure 6 Severe delamination of the right-hand side sandstone leading to loss of stone surface

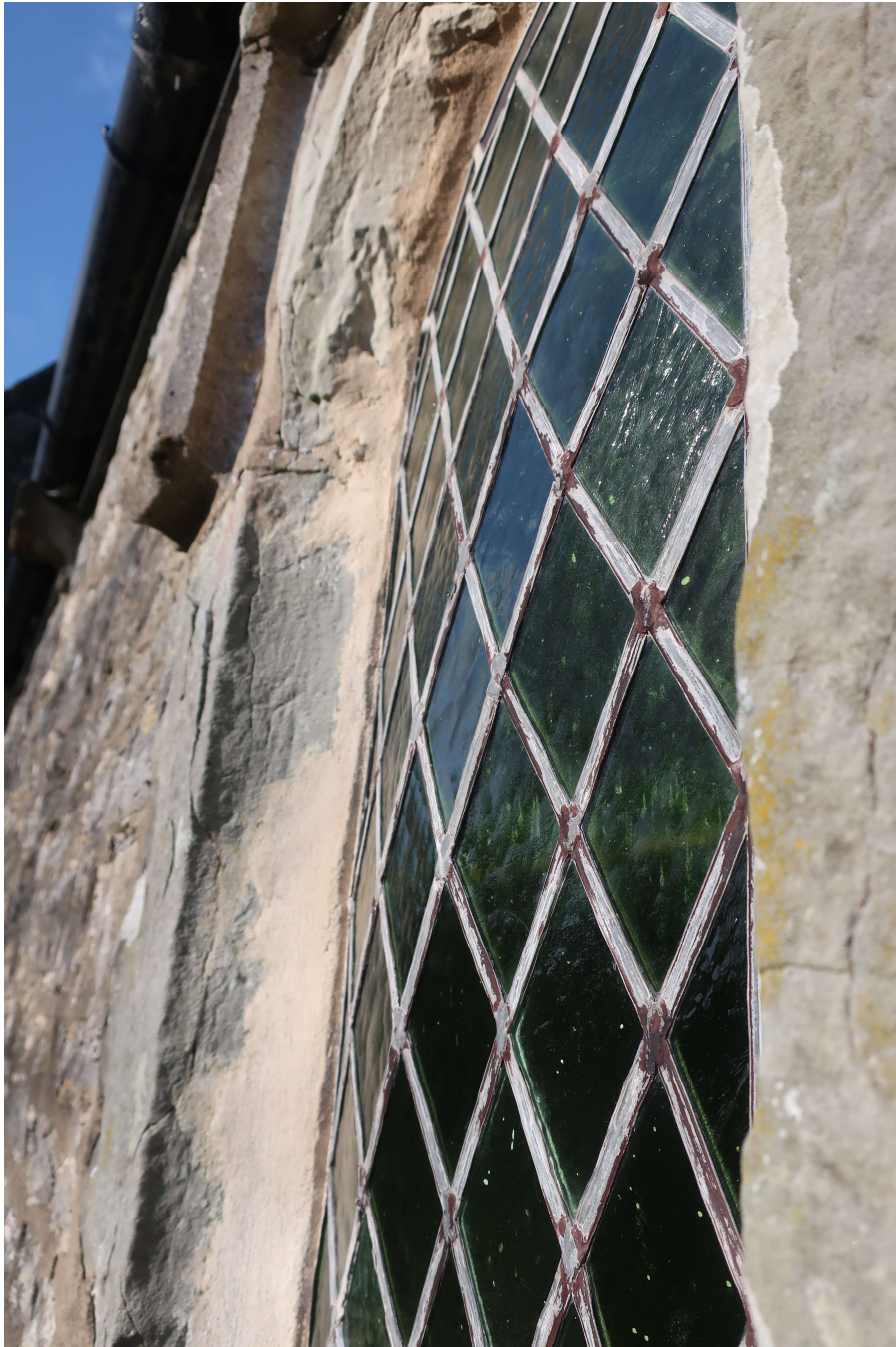
The stained-glass panel is bulging toward the outside but it is structurally stable. Several glass squares (quarries) of the panel are shown stress cracks as a result of structural movement. The surface of the lead 'comes' is covered in white and brown lead corrosion as a result of exposure to the elements. Deep delamination fissures are present in the masonry and these are exacerbated by pressure from surrounding hard cement joints leading to losses in the top layer of stone.

Figure 7 Side photo showing the bulging window

It is suggested that when a window is bulging more than 1" (25mm) out of plane it has reached the point where it should be removed from the opening to be flattened out. However, in this case the window panel is set with hard

cement in the masonry frame, thus the extraction process is more difficult and dangerous for the glass panel.
